Manhole Inspection Summary

Manhole # S25II1016MH

Location Address: **4223 HICKORY AVE**

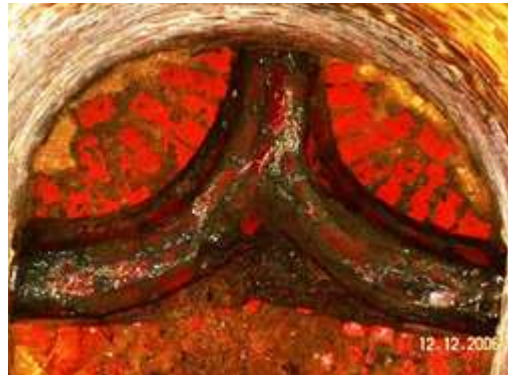
Top View

Bench debris.

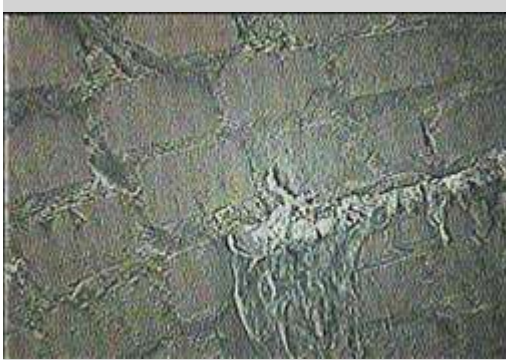
Defect

Condition: ☐ Sound ☐ Cracked ☐ Root Intrusion ☐ Loose Brick ☒ **Deteriorated**

Infiltration: ☐ None ☐ Joint ☐ Cracks ☒ **Mortar** ☐ Roots ☐ Wall

☒ **Evidence Of Surcharge** Depth: **8** (ft.) ☐ Active Surcharge Present

Corbel deterioration and infiltration.
Evidence of surcharge.

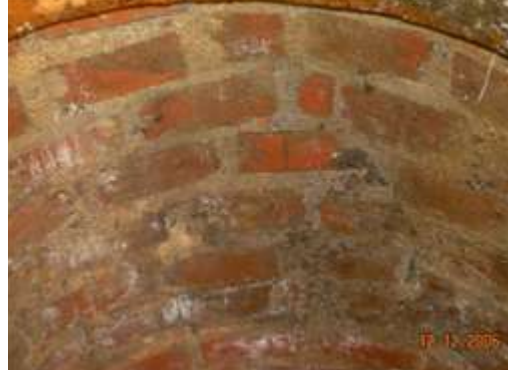
Defect

Infiltration: ☐ None ☒ **Joint** ☐ Cracks ☐ Mortar ☐ Roots ☐ Wall

Adjustment infiltration.

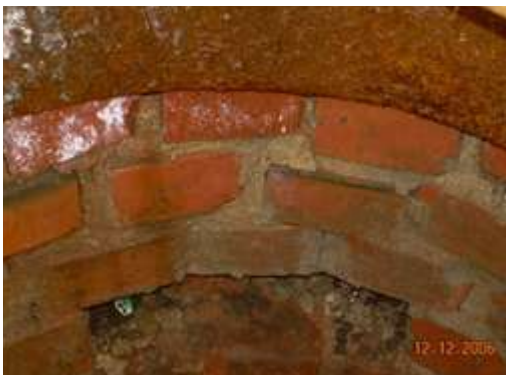
Defect

Condition: ☐ Sound ☐ Cracked ☐ Root Intrusion ☐ Loose Brick ☒ **Deteriorated**

Adjustment deterioration and infiltration.

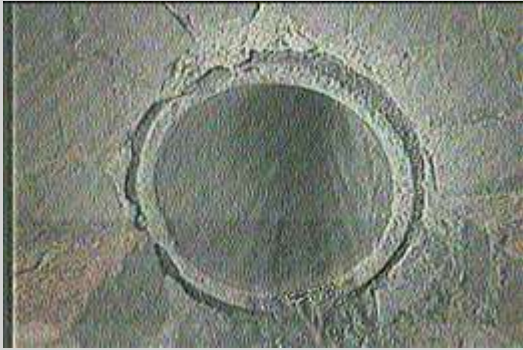
Pipe In @ 9 O'Clock

Comments **The I3 and the I9 pipe seals are not flush to the pipes.**

Infiltration: **Evidence**
